NASA  
Technical  
Paper  
2032

# Buckling Test of a 3-Meter-Diameter Corrugated Graphite-Epoxy Ring-Stiffened Cylinder

Randall C. Davis

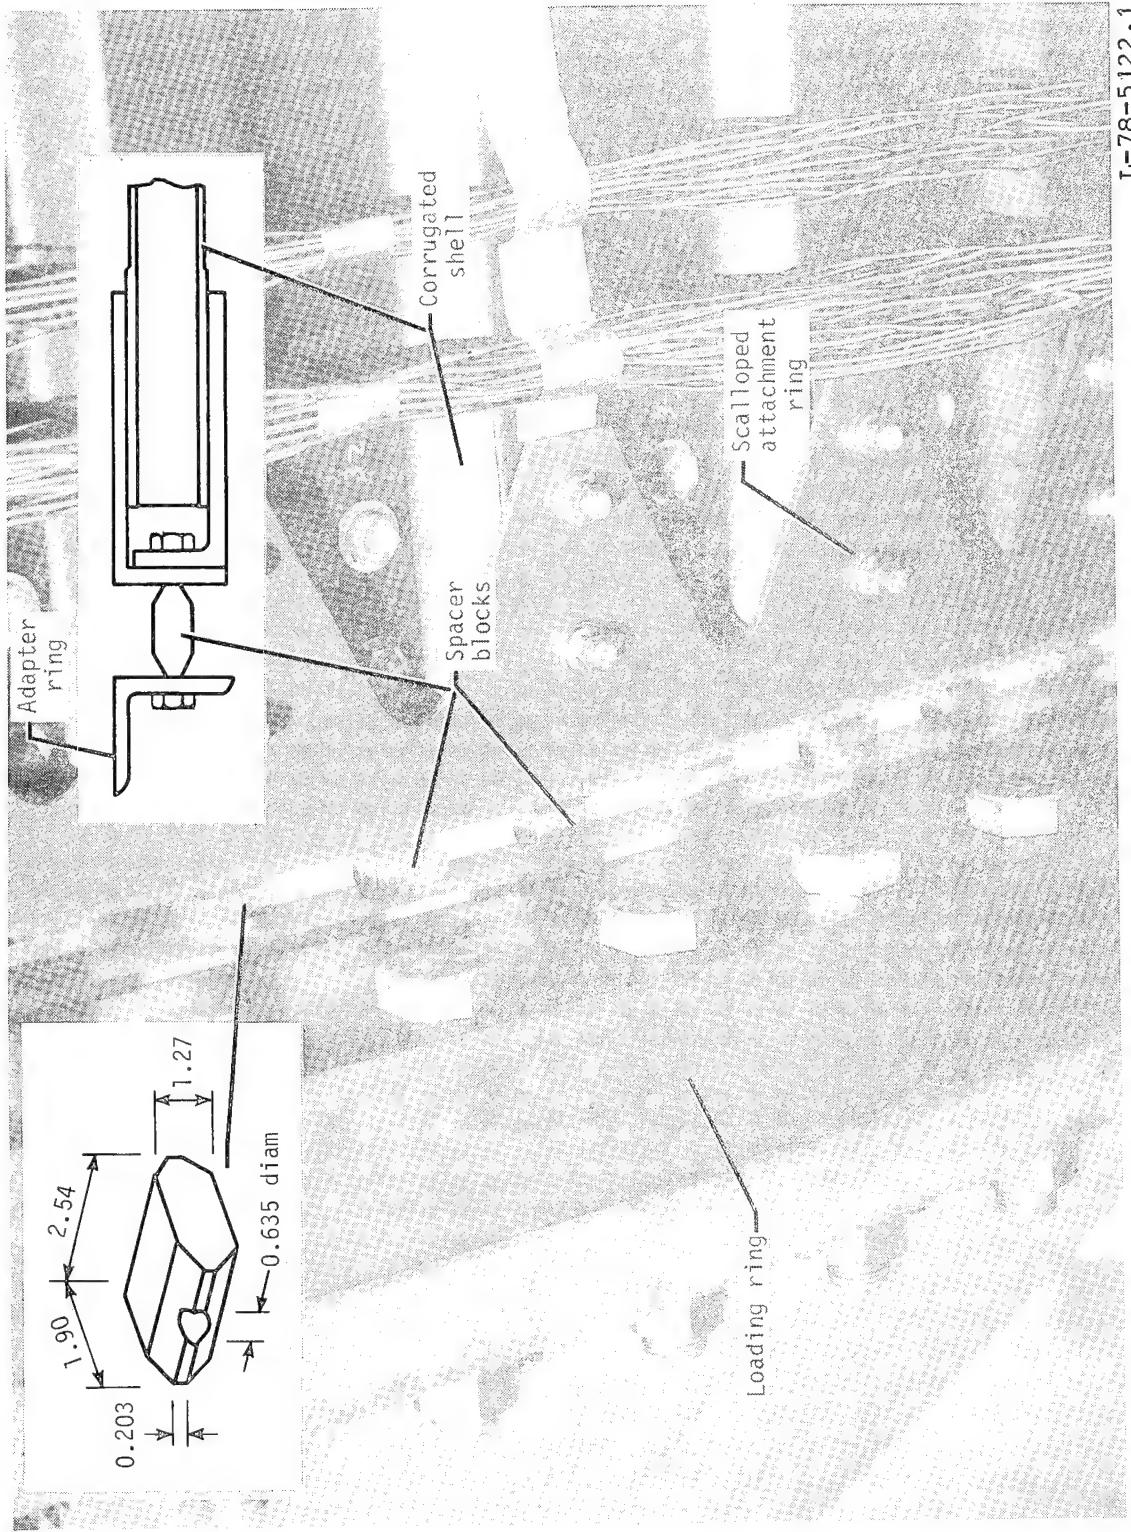
L-78-5122.1

An examination of strain-gage data from a preliminary test of the cylinder at 30 percent of design load revealed a severe load introduction problem at the ends of the cylinder. A 5.56-cm offset between the centroid radius of the loading ring and the midsurface radius of the shell wall produced an inplane ring rolling moment in the loading rings that produced substantial shell-wall bending at the ends of the shell. The severity of the shell-wall bending caused concern over the possibility of premature buckling of the cylinder.

A second preliminary test made with the spacer blocks in place indicated that the bending strains in the shell wall were sufficiently reduced to allow a successful buckling test of the cylinder. No buckling or material failures were observed near the loaded ends of the shell during subsequent testing, indicating that the spacer blocks had sufficiently reduced the shell-wall bending strains to prevent a premature failure.

Figure 6.- Spacer blocks in place between scalloped attachment ring and adapter ring. Dimensions are in centimeters.

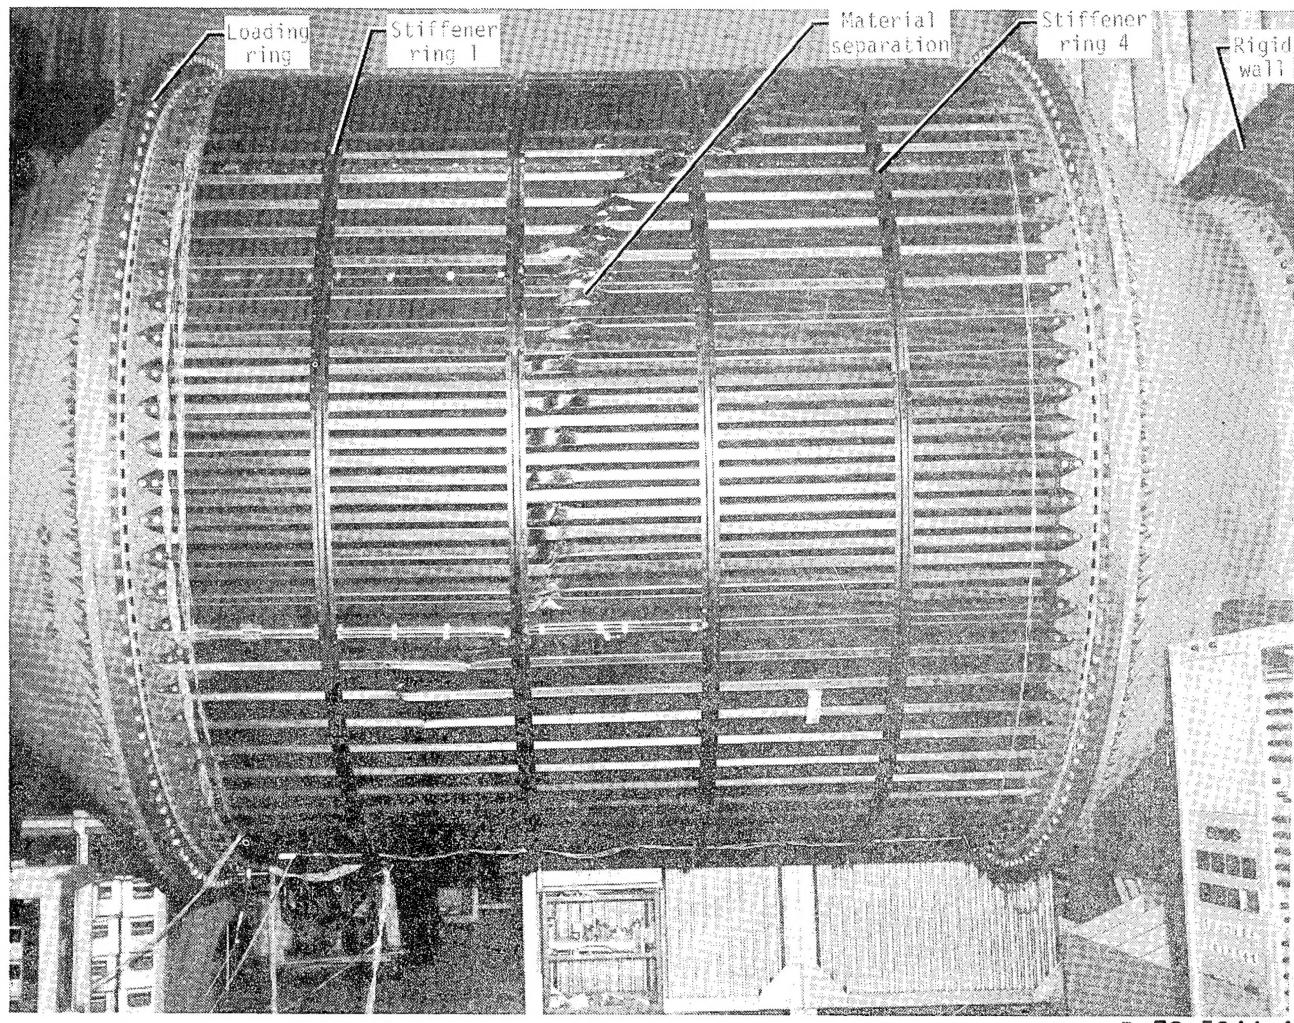
The location of strain gages on the top section of the cylinder is shown in figure 10, and the response data from these strain gages are shown in figures 11 through 13. Because of bending in the crown, local buckling appears in back-to-back strain-gage data plots as a divergence of the two strain-response curves. At local buckling, one of these two strain-response curves reaches a point of maximum strain before reversing. General instability modes in the shell wall, however, result in a bending moment across the depth of the corrugation. Thus, this mode is characterized by divergence and reversal response curves of the back-to-back strain-gage pairs on adjacent corrugation crowns where one crown is on the inward side of the shell wall and the other crown is on the outward side of the shell wall. As can be seen from the response curves in figures 11 through 13, there is evidence of local and general instability modes occurring simultaneously in the shell wall. The shell walls between rings 1 and 2 and rings 2 and 3 show a pronounced general instability mode behavior. Between rings 3 and 4, however, local buckling behavior occurred prior to general shell instability, as indicated by the responses of gages 33 and 34. The occurrence of this local buckling mode produces a local reduction in crown stiffness, which in turn causes a reduction in overall bending stiffness of the shell wall in that area. As a result, it is probable that a general instability mode developed as a result of the pronounced local instability, resulting in a loss in overall shell-wall bending stiffness in the area. The shell collapsed with a sudden loss of load-carrying capability in a general instability mode between rings 3 and 4 at a load 101 percent of the desired ultimate load. The strain levels produced during this instantaneous collapse were sufficient to cause material separation in the shell wall extending over two-thirds of the circumference of the cylinder. (See fig. 14.)

Local buckling modes in the shell-wall corrugations were observed to interact with the general shell mode to cause a collapse failure of the shell. Details of the method of load introduction proved to be critical, and a cautious test procedure led to a modification of the load introduction fixtures. This modification prevented a possible premature failure of the test specimen. Comparisons of axial strains along the top of the shell from the test and from a detailed shell-of-revolution analysis were used to prove the concept for modifying the load introduction fixtures. The desired design ultimate load of  $157.6\text{ kN/m}$  was reached before buckling, and the overall shell-wall mass was  $1.96\text{ kg/m}^2$  for the mass-strength optimized, corrugated, graphite-epoxy cylinder. At 101 percent of the design ultimate load, the shell collapsed suddenly and catastrophically, with severe material separation over two-thirds of the shell circumference. A substantial mass-saving potential was demonstrated compared with available data for corrugated aluminum designs.

Figure 14.- Photograph of corrugated cylinder immediately after failure with postbuckled load still applied.
